Rapid repair of RC bridge columns subjected to earthquakes

A. Vosooghi & M. Saiid Saiidi

University of Nevada at Reno (UNR), Reno, Nevada, USA

J. Gutierrez

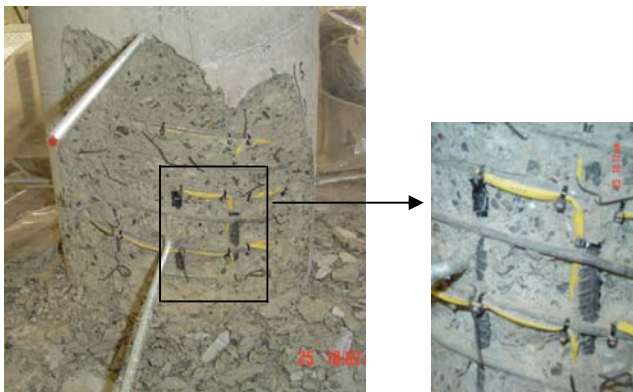
The bridge model was a one-quarter scale two-span reinforced concrete bridge supported on three two-column bents, each supported on one of the UNR shake tables. Figure 1 illustrates the general view of the test set up. The bent that was the subject of emergency repair was the middle bent (Fig. 2) because it underwent approximately 8% drift during the previous dynamic shake table tests and experienced the most severe damage. The bent was pushed statically to 10% drift after the dynamic tests to impose more damage in the core without failing the bars. The drift is defined as the ratio of the lateral displacement at the top to the column height. The maximum longitudinal bar strain was 72,674 microstrains (approximately 31 times the yield strain), and the maximum spiral bar strain was 1,436 microstrains (74% of yield). Figure 3 shows the damage at one of the plastic hinges.

Figure 3. Damage in West column at bottom; West view

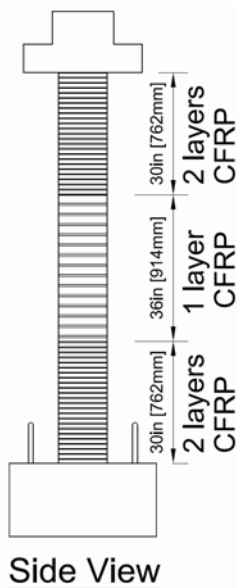
The material properties are listed in Table 1. The lower limits of specified values were used for repair design. The required CFRP thicknesses to restore confinement were 0.058 in (1.5 mm) and 0.029 in (0.7 mm) inside and outside of the plastic hinge zone, respectively. The required CFRP thickness to restore the shear strength was 0.036 in (0.9 mm) on entire column height. Two layers of CFRP were used over the plastic hinge zones with a length of $1.5D=18$ in (457 mm) and one layer elsewhere. The repair design sketch is shown in Figure 4. A jacket system with a thickness of 0.041 in (1.0 mm) per layer was used.

Figure 4. Repair design sketch

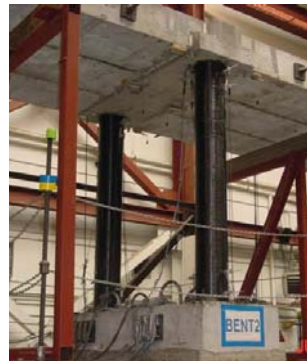
Figure 9. Wrapped columns

After preparing the surface, CFRP layers were saturated in the epoxy and then wrapped around the columns manually. Figure 9 shows the wrapped columns.

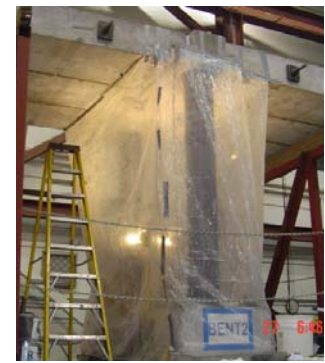
Figure 10. Curing process

After wrapping CFRP, the temperature was elevated to a range of $94^{\circ}F$ ($34^{\circ}C$) to $100^{\circ}F$ ($38^{\circ}C$), and the relative humidity was reduced from 19%-21% to approximate 10%. This was accomplished by hanging plastic sheet from the bridge soffit, using four 1000-watt lamps, directed away from the columns, a resistive heater, and a fan. Figure 10 shows the setup.
