Rapid repair of RC bridge columns subjected to earthquakes

A. Vosooghi & M. Saiid Saiidi

University of Nevada at Reno (UNR), Reno, Nevada, USA

J. Gutierrez

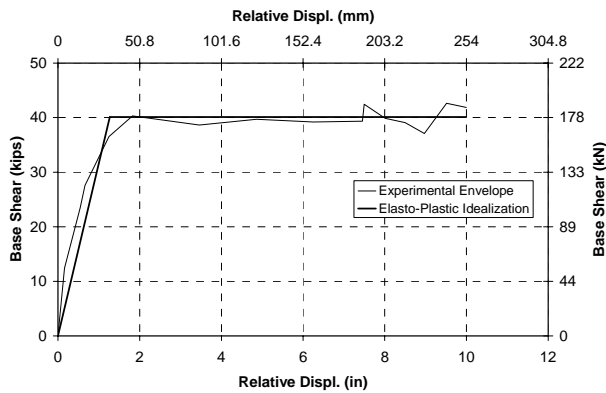
Figure 11. Force-displacement relationship for pre-repair tests

Figure 11, and 12 for pre-repair and post-repair tests respectively.

The first significant FRP jacket was observed in Test 07. During this test, the FRP jacket ruptured on the west face in the bottom side of the west column (Fig. 13). The rupture was accomplished with a loud noise. After that, there was a drop in the bent base shear. The second FRP breakage was heard in Test 10, but no more rupture was apparent. In Test 11, two more noises were heard due to the rupture of FRP. The FRP ruptured on the west face in the bottom side of the east column (Fig. 14).
